Addendum No. 1

Las Acequias de Las Trampas Flume Rehabilitation Project

ACEQUIA DE LAS TRAMPAS GEOTECHNICAL REPORT
GEOTECHNICAL REPORT
TAOS COUNTY, NEW MEXICO
Publish Date: 1/15/2024

Subject: Acequia de las Trampas Log Flume Rehabilitation Project

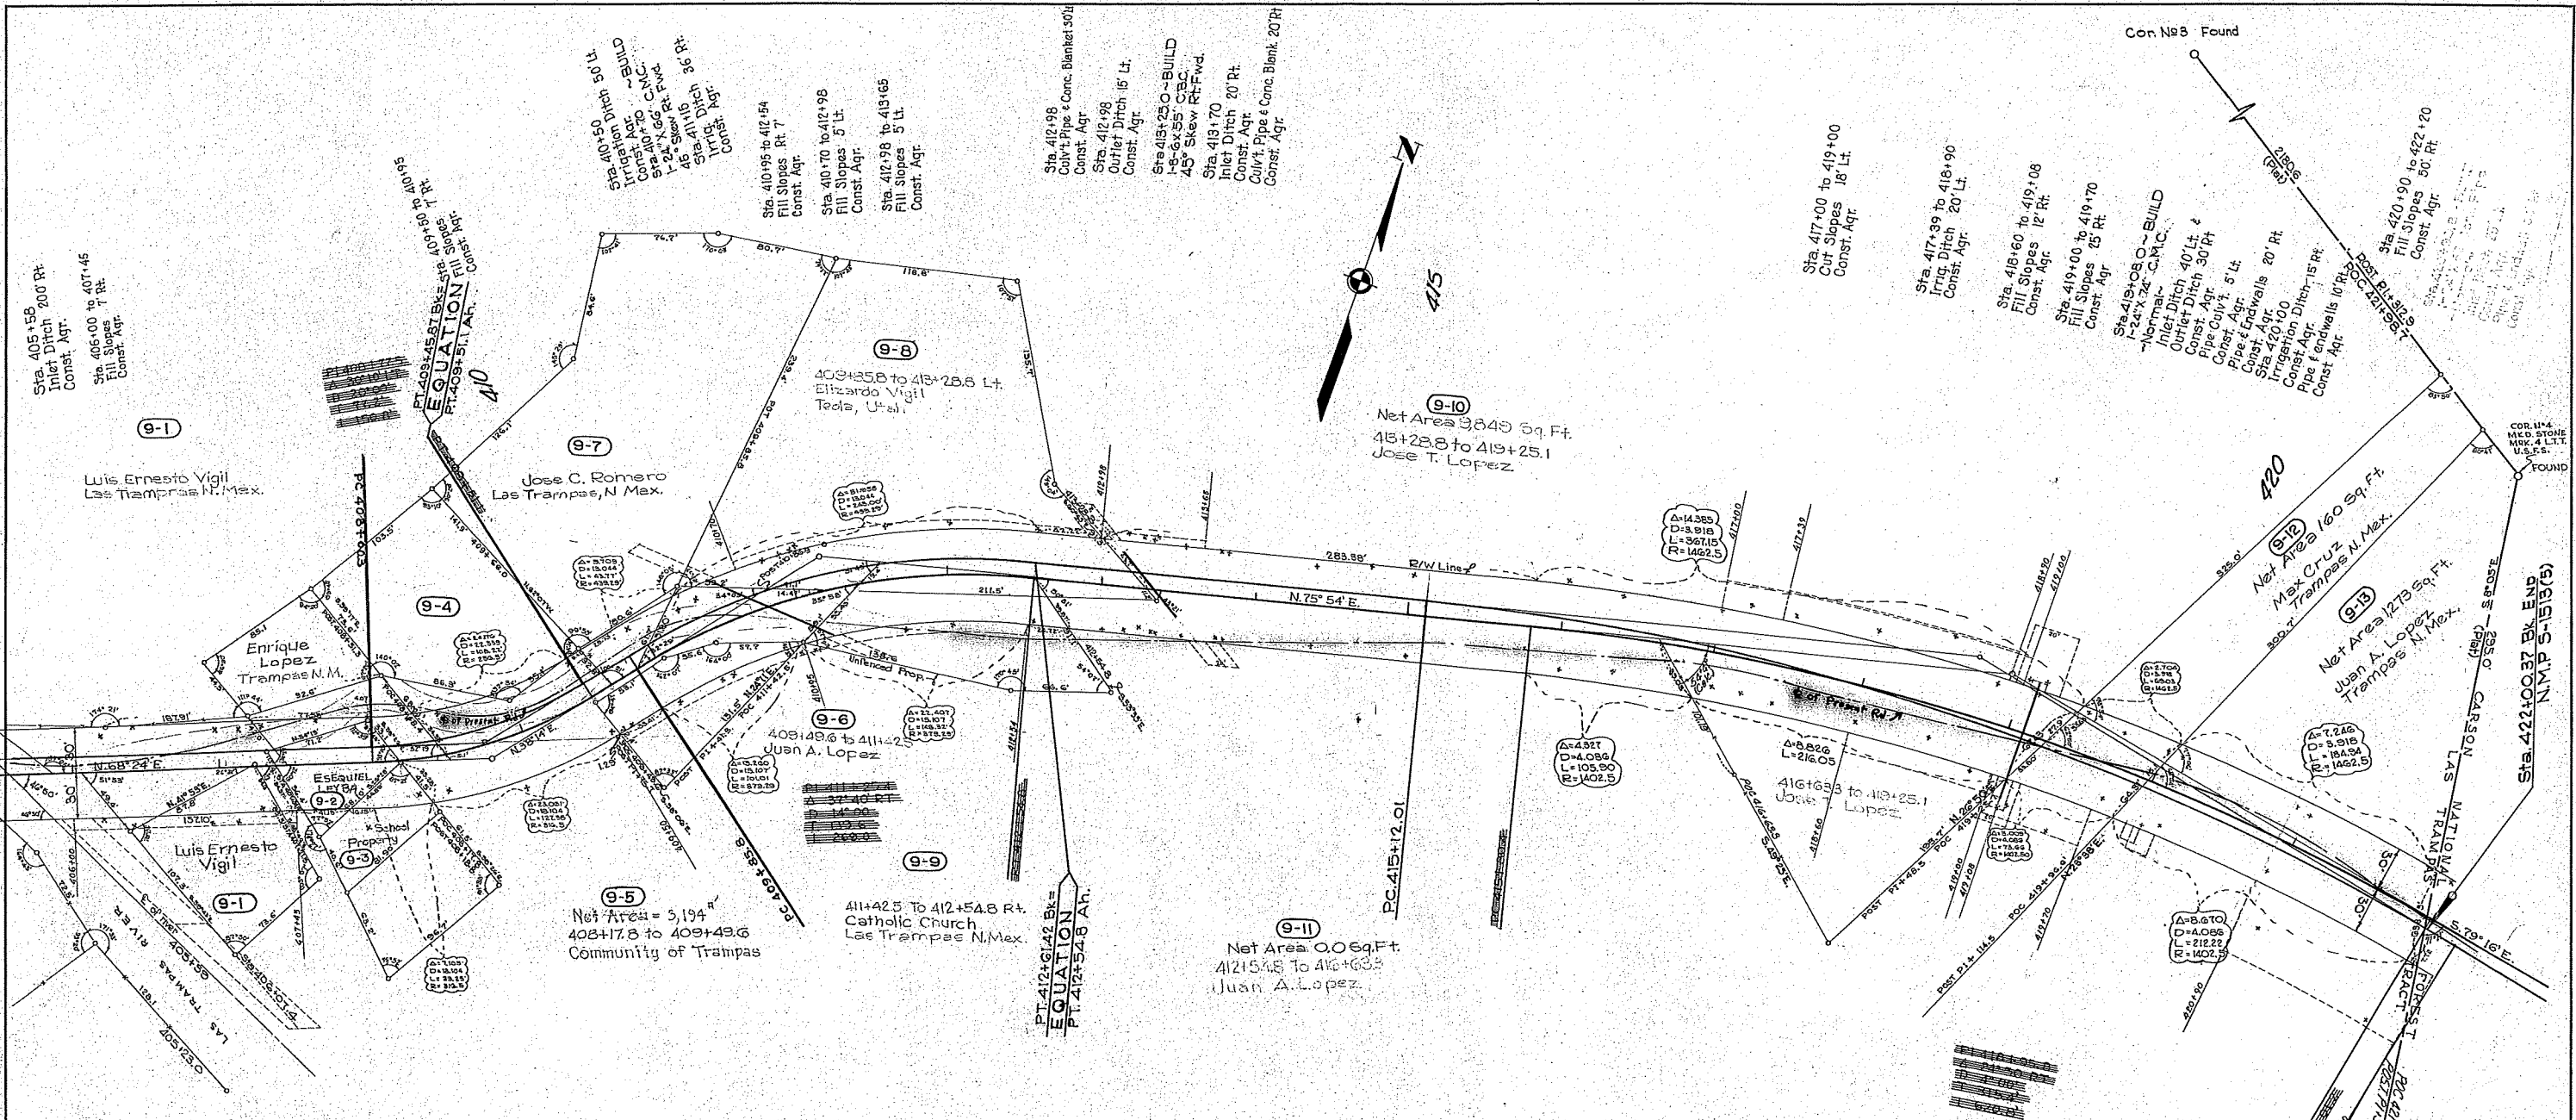
NEW MEXICO STATE HIGHWAY COMMISSION
 RIGHT OF WAY MAP
 NEW MEXICO PROJECT NO.
S-1513(5)
 TAOS COUNTY
 SCALE 1" = 50'
 SHEET 9 OF 12

LAS TRAMPAS TRACT.

- 9-1) Area Taken 1,143 Sq.Ft.
- 9-2) Area Taken 4,506 Sq.Ft.
- 9-3) Area Taken 842 Sq.Ft.
- 9-4) Area Taken 212 Sq.Ft.
- 9-5) Area Taken 3,194 Sq.Ft.
- 9-6) Area Taken 2,614 Sq.Ft.
- 9-7) Area Taken 0.0 Sq.Ft.

NOTE:
 ○ INDICATES RE-SET NAILS
 **** INDICATES LIMITS OF CUT OR FILL SLOPES AS PER PLANS

Answer: The proposed structures, including the outlet structure for the flume, are located approximately 31' from the highway centerline and are outside of the existing highway right of way (30' offset from road centerline, as shown in attached plat from NMDOT). However, it is anticipated that the Contractor may need to temporarily excavate into the highway right of way, to install the proposed outlet structure. At a minimum, the Contractor will need to obtain a Traffic Control/Roadway Work Permit for implementation of the Contractor's approved Traffic Control Plan. It will be the responsibility of the Contractor to contact NMDOT and obtain applicable permits if the Contractor must cause temporary disturbance to the highway right of way for completion of the work in the contract documents.

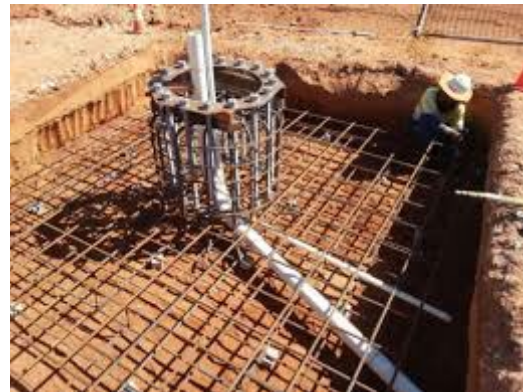
Figure 2 Pad and Pier Foundation

Shallow spread footings are commonly specified for grade separated structures and typically a viable method to resist design loads, footings are at the top of a hierarchy of selection type. The advantages of shallow footings include ease of construction using traditional earth moving equipment without the need for a specialty contractor. In addition, materials are readily inspected and tested, construction material testing and agency compliance is practical, adequacy of bearing conditions can be readily observed for agency compliance. In areas of poor subgrade conditions, details can be developed to stabilize and reinforce the bottom of footing with an engineered fill detail included in the contract. The weight of the slab embedded in the ground also provides increased stability of the entire structure and can improve slope stability by extending the bottom of footing deeper into the subsurface. The disadvantages of a spread footing foundation are that it will require a considerable amount of excavation, reinforcement, and concrete to be used for the monolithic construction. The concrete is susceptible to edge corrosion if not properly protected. Another disadvantage is that eccentric loading reduces the bearing resistance of the foundation. Similarly, constructing footings on slopes will lead to a reduction in the bearing resistance of the foundation system. A pad and pier type of spread footing is commonly used to support communication towers and may provide added stability for the center pier. The pad and pier type of foundation with spread footing base would reduce the amount of concrete compared to monolithic footing.

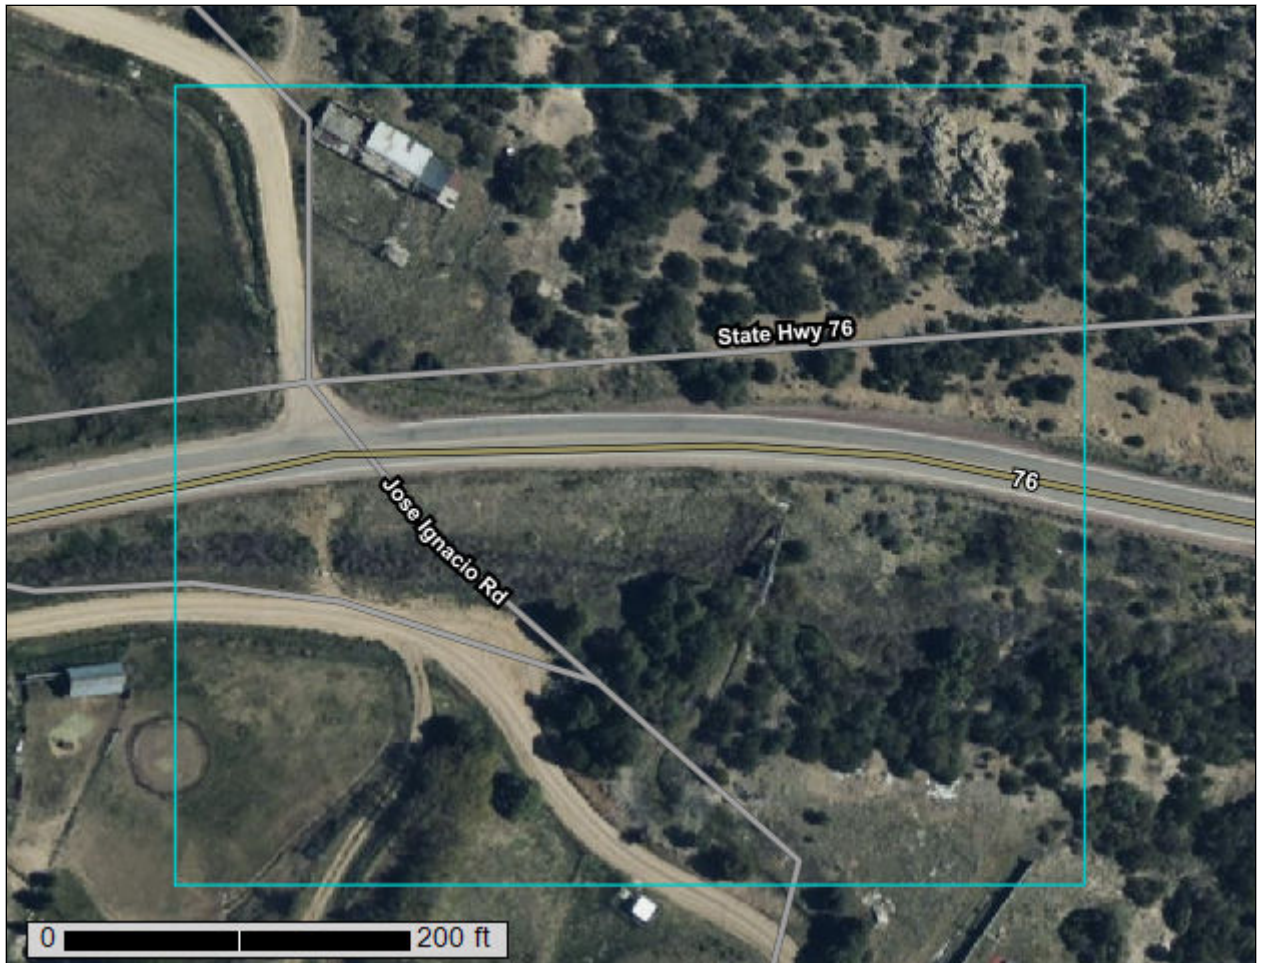
Custom Soil Resource Report Soil Map

Custom Soil Resource Report for Taos County and Parts of Rio Arriba and Mora Counties, New Mexico

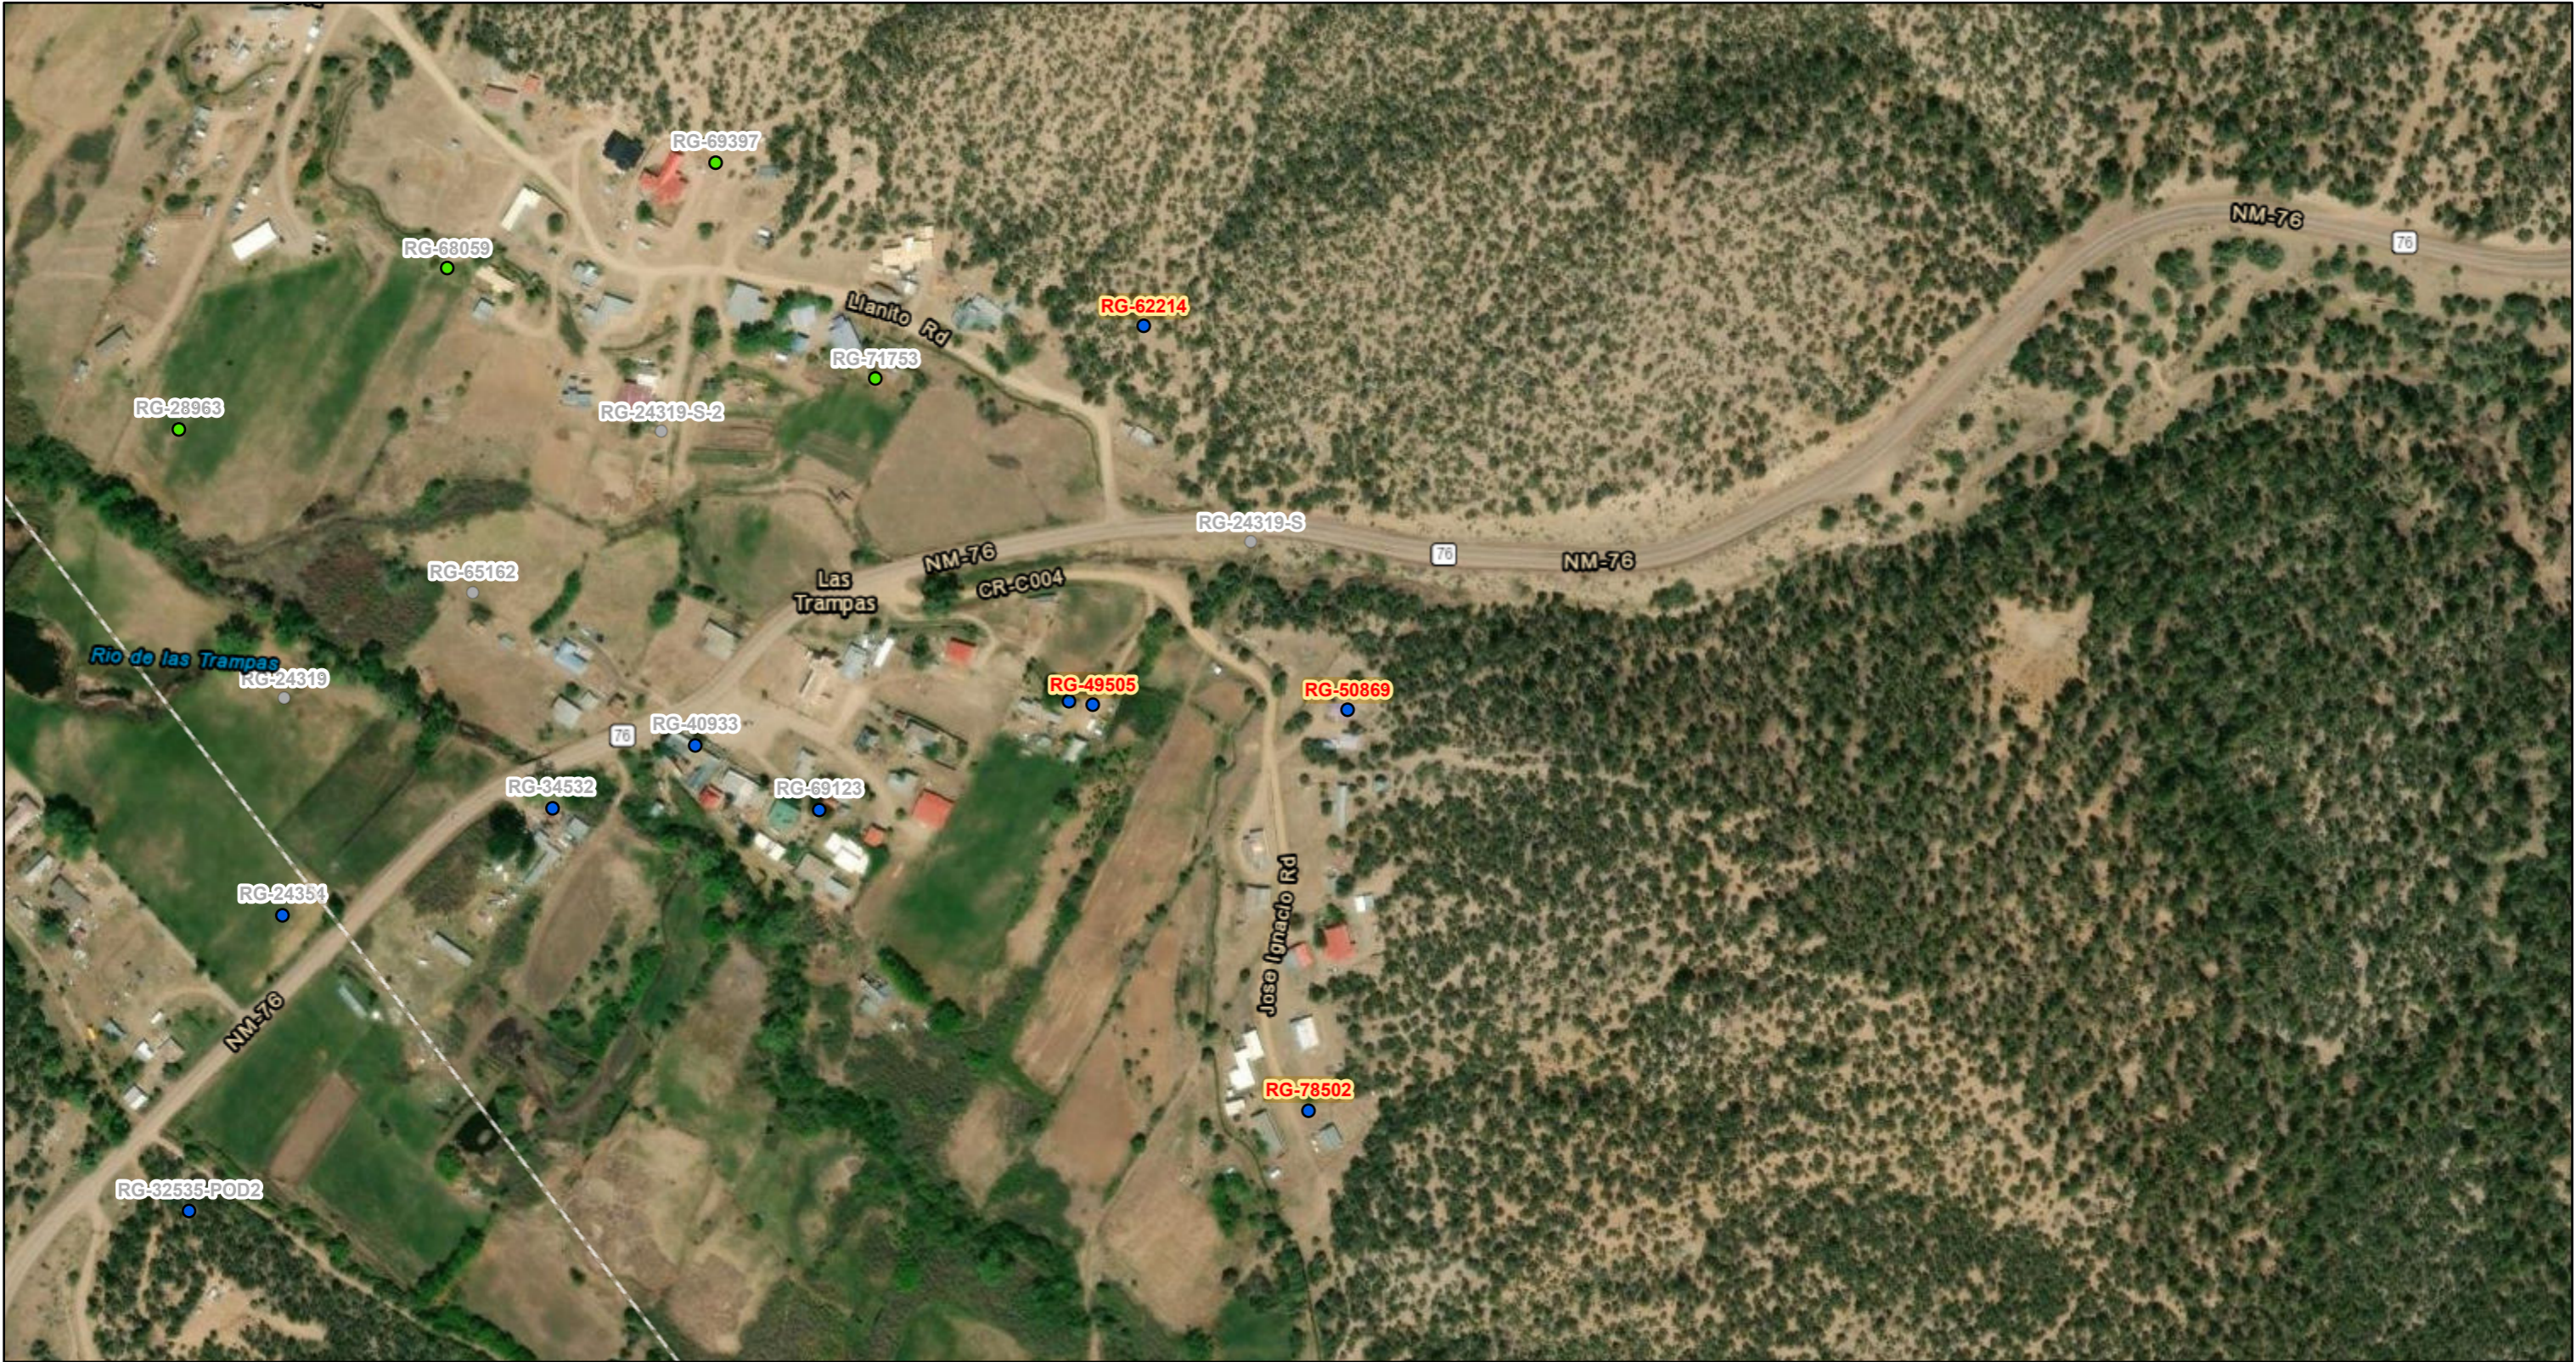
OSE POD Location Map

Water Right File No.	RG-49505	RG-50869	RG-62214	RG-78502
Borehole Proximity	350 ft SW of Site	200 ft SE of Site	500 ft NW of Site	1,000 ft South of Site
Date of Completion	07/1988	04/1990	05/1995	06/2003
Depth of Well, ft bgs	80	120	130	100
Depth to Static Water Level, ft bgs	20	70	84	32
Water-Bearing Formation	Sand & Gravel (50-80 ft bgs)	Sedimentary Rock (80-110 ft bgs)	Fractured Limestone (126-130 ft bgs)	Clay, sand & gravel (32-63 ft bgs)
Other Types of Material Encountered	Clay & Cobbles (0-25 ft bgs)	Caliche (2-16 ft bgs)	Gravel (0-23 ft bgs) Shale (46-86 ft bgs)	Decomposed granite & quartz (63-100 ft bgs)
Estimated Yield, GPM	15	10	7	12
<i>Note: ft=Feet, bgs=Below Ground Surface, GPM=Gallons per Minute, N/A=Not Available</i>

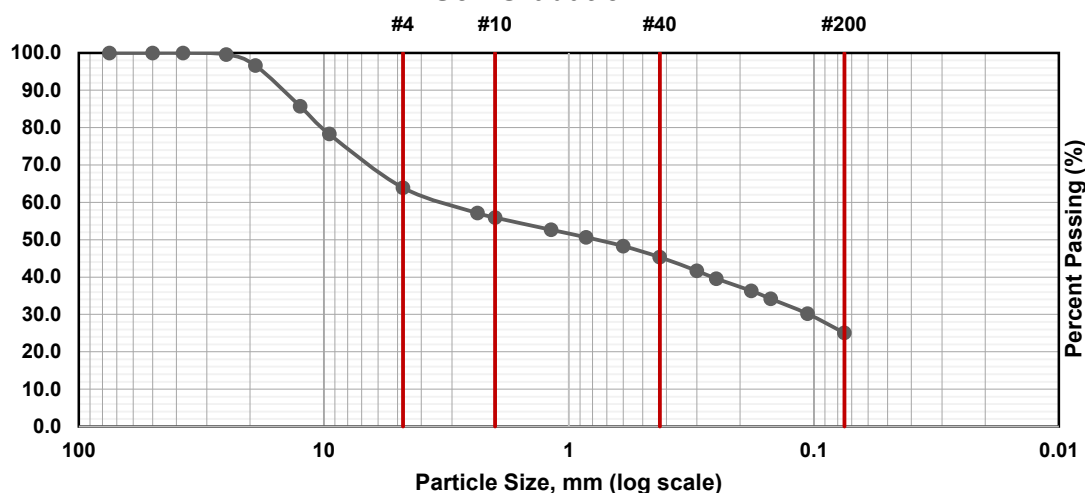
Soil Gradation

Gradation	
Dispersion Process:	<input type="checkbox"/> Ultrasonic bath <input type="checkbox"/> Shaking Apparatus <input checked="" type="checkbox"/> None
ASTM D2487 Classification:	
Group Name:	Clayey sand with gravel
Group Symbol:	SC
AASHTO Classification - ASTM D3282-15:	
Group Name:	A-2-6
Atterberg Limits: ASTM D4318-17	
Liquid Limit:	31
Plastic Limit:	18
Plasticity Index:	13
Shape Parameters:	
Fineness Modulus:	3.273
C_U :	31.47
C_C :	0.06
D_{60} :	2.360
D_{30} :	0.106
D_{10} :	0.075

Sieve Size	% Passing
3"	-
2"	-
1 1/2"	100
1"	100
3/4"	97
1/2"	86
3/8"	78
#4	64
#8	57
#10	56
#16	53
#20	51
#30	48
#40	45
#50	42
#60	40
#80	36
#100	34
#140	30
#200	25

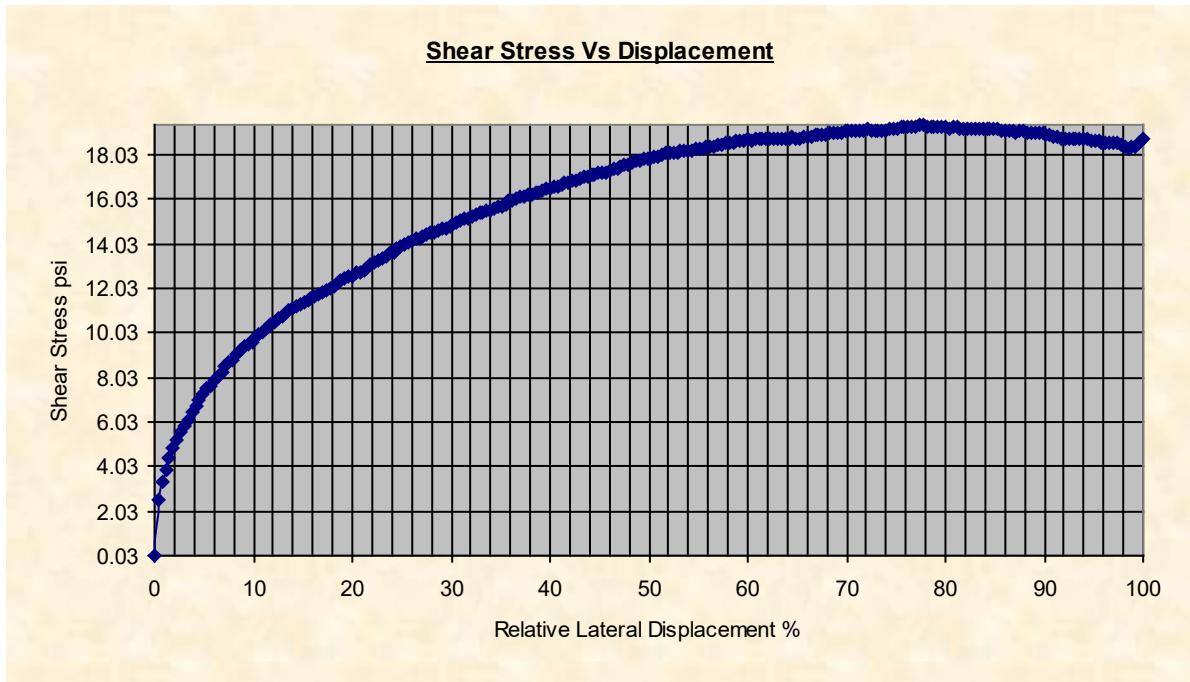
Shear Strength by Direct Shear (Small Shear Box)

Rate of Horizontal Displacement	Stage 1: 0.011800in/min
--	-------------------------

Conditions at Failure	
Normal Stress	29.63 psi
Peak Strength	19.39 psi
Horizontal Deformation	0.1844 in
Residual Stress	0.00 psi
Vertical Deformation	0.0167 in

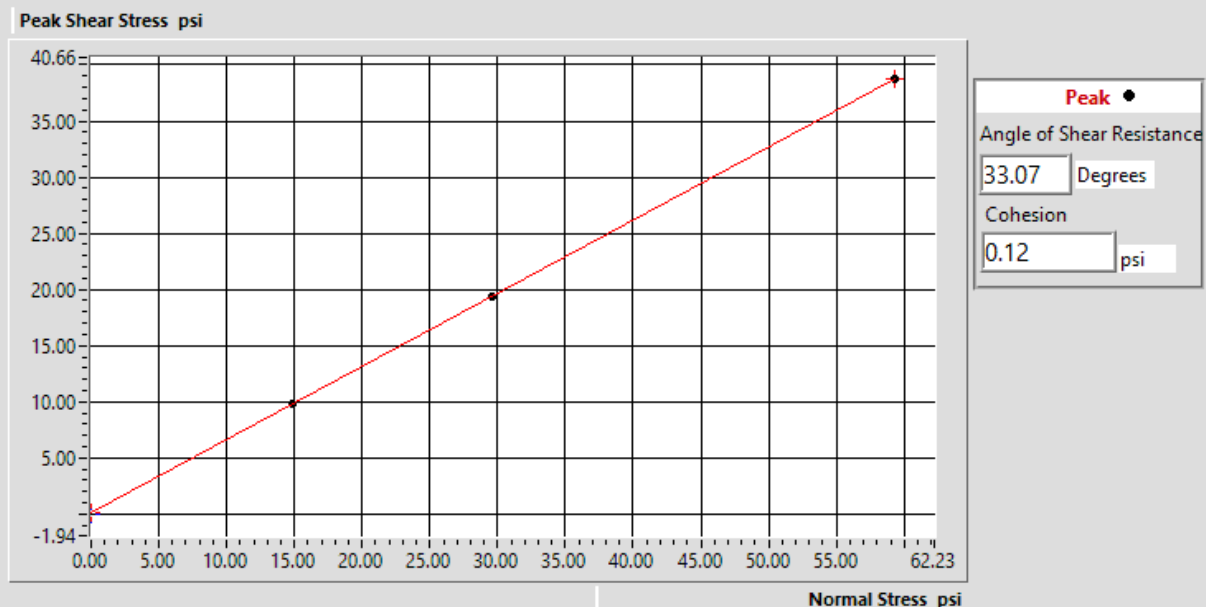
Maximum Shear Stress vs Normal Stress

Sample ID	ID	Laboratory Soil Test Initial Specimen Conditions	Depth (feet)	Angle of Shear Resistance ($^{\circ}$)	Cohesion (psi)
222-04	GR-01	Silty Sand, Initial Dry Density 118 pcf at 9% MC	3 to 4	33.1	0.12

Reference	A	B	C
Normal Stress	14.80 psi	29.63 psi	59.26 psi
Peak Strength	9.78 psi	19.39 psi	38.72 psi
Corresponding Horizontal Displacement	0.2462 in	0.1844 in	0.1853 in
Residual Stress	N/A	N/A	N/A
Rate of Shear Displacement	Stage 1: 0.015750in/min	Stage 1: 0.011800in/min	Stage 1: 0.011800in/min
Final Height	0.9695 in	0.9713 in	0.9339 in
Sample Area	4.60820 in ²	4.60820 in ²	4.60820 in ²
Initial Wet Unit Weight	126.94 lbf/ft ³	129.23 lbf/ft ³	128.93 lbf/ft ³
Initial Dry Unit Weight	116.44 lbf/ft ³	118.54 lbf/ft ³	118.28 lbf/ft ³
Final Wet Unit Weight	137.25 lbf/ft ³	138.02 lbf/ft ³	143.48 lbf/ft ³
Final Dry Unit Weight	120.11 lbf/ft ³	122.04 lbf/ft ³	126.65 lbf/ft ³
Final Moisture Content	14.27 %	13.10 %	13.29 %
Particle Specific Gravity	2.65	2.65	2.65
Final Void Ratio	0.3779	0.3561	0.3067
Final Saturation	100.08%	97.50%	114.83%

The drained shear strength was determined in the laboratory per ASTM D3080. The sand material was reconstituted, and three points were assessed by YeDoma's senior engineer to determine the failure envelope, apparent cohesion intercept and angle of shear resistance. The laboratory soil tests were prepared at a dry density of 118 pcf based on our experience with similar soils. The results are summarized in Table 10. The detailed test reports are included in the Appendix. The angle of shear resistance determined by YeDoma is consistent with published values for granular sand material.
